General Aviation Airworthiness Alerts

AC No. 43-16

**ALERT NO. 220
NOVEMBER 1996**

**Improve Reliability-
Interchange Service
Experience**

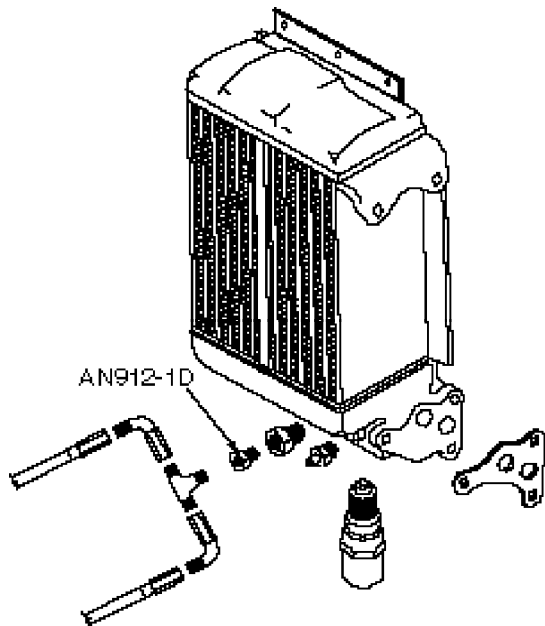
Beech	Turbocharger Oil
Model A36	Leak
Bonanza	8120

An investigation revealed that a fitting (P/N AN912-1D) on the turbocharger oil cooler was broken. This fitting is constructed of aluminum and reduces in size from .25 inch to .125 inch. (Refer to the following illustration.) This engine (IO-550-B-1F) had been fitted with a Supplemental Type Certificate (STC) SA5223NM, which installed a turbocharger normalized system. The broken fitting was installed as a part of the STC. The STC holder, Flightcraft, Inc., has revised their data to install a fitting made of steel. All operators who have this STC installed should have the system inspected for the presence of the aluminum fitting. If this aluminum fitting is found, contact the STC holder for replacement instructions.

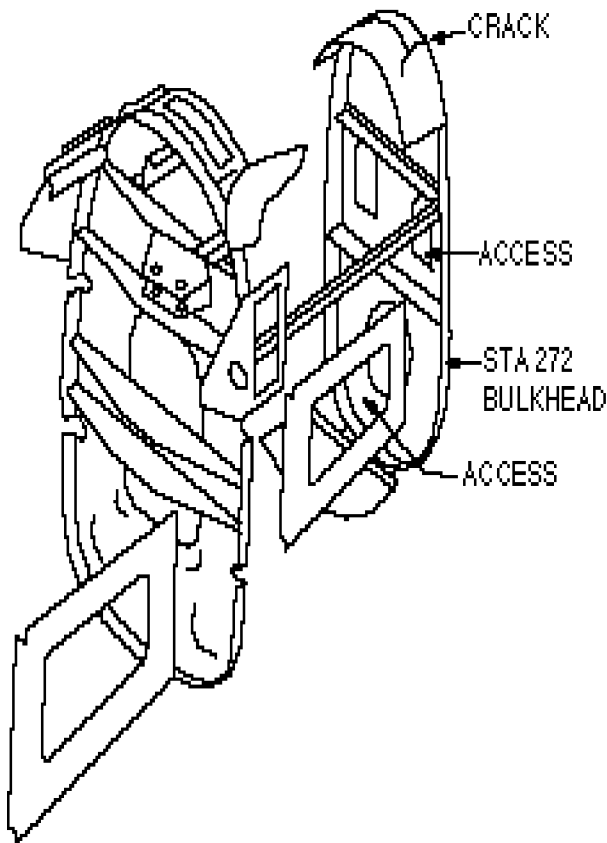
Beech	Bulkhead Structural
Model A36	Crack
Bonanza	5500

During a scheduled inspection, a crack was found in the empennage bulkhead structure.

The crack was located in a bulkhead doubler (P/N 002-440000-29) just forward of Fuselage Station 272. The crack originated in the radius cutout area of the doubler on the left side. (Refer to the following illustration.) The operator inspected the remainder of the fleet, and five similar defects were discovered.

The area where the crack was found is part of the reinforcement for the attachment point of the rear spar for the vertical stabilizer. The location of this defect makes it very difficult to properly inspect. A mirror and flashlight are required, and access to the area can be gained through the inspection panel on the left rear of the fuselage (with the tail cone removed). The submitter recommended frequent inspection of this area.

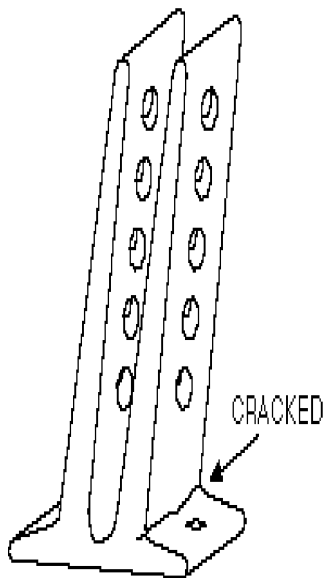
Empennage Fitting
Crack
5553

A crack in the vertical fin attachment was discovered while complying with Airworthiness Directive (AD) 80-11-04.

The crack was approximately .875 inch long and was located on the lower outboard side of the left vertical fin attachment fitting (P/N 0431009-3). (Refer to the following illustration.) When the fitting was removed, the cracked section of the fitting broke. The submitter did not offer a cause for this defect.

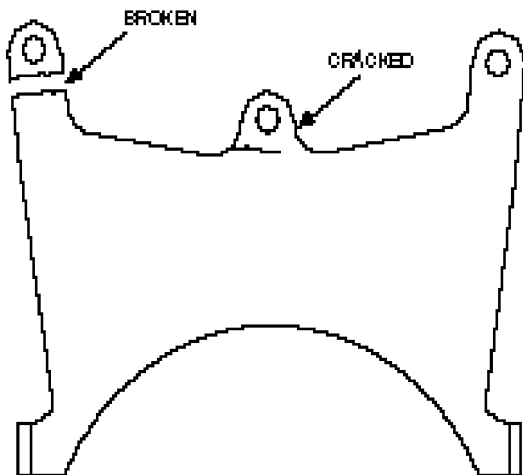
Piper	Generator Support
Model PA 22-135	Bracket Failure
Tri-Pacer	5345

During an annual inspection, the technician discovered the generator was loose.

Further investigation revealed the generator support bracket (P/N 69113) had one broken ear and one cracked center ear. (Refer to the following illustration.)

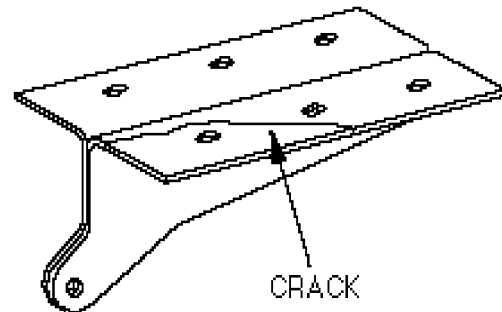
Elevator Trim Tab
Horn Crack
5552

During a scheduled inspection, the elevator trim tab horn assembly (P/N 43221-00) was found cracked.

The crack ran from the forward lower corner aft to just below the second rivet. (Refer to the following illustration.) Further investigation revealed the rivets, used to attach the horn

assembly to the forward side of the spar, were loose and working. There was also evidence of a poorly done previous repair.

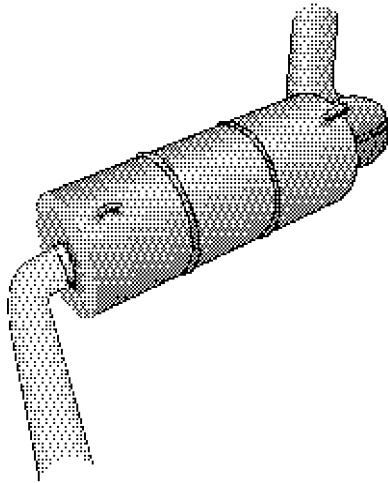
During a routine preflight inspection, the mechanic discovered a loose exhaust pipe.

After removing the cowling, a closer inspection found the exhaust pipe was almost completely separated from the muffler assembly. This pipe exits the muffler at an immediate 90-degree elbow. At this point it is welded to the end of the muffler with approximately an 8-inch tailpipe which protrudes through the lower cowling. The pipe had separated completely around the weld except for approximately .25 inch of weld attachment left holding it to the muffler. (Refer to the following illustration.) The apparent causes were the use of “MIG” welding for attachment and the failure to normalize the welded area. Normalizing should always be done after “MIG” welding because the very localized heating creates a brittleness of the surrounding material. The submitter stated that this muffler was as it was received from the supplier of the kit with no modifications and 110 hours total time.

The submitter also stated: “This part of the preflight should never be ignored because had the pipe completely separated during flight, the result of raw exhaust inside the cowling could have been catastrophic.”

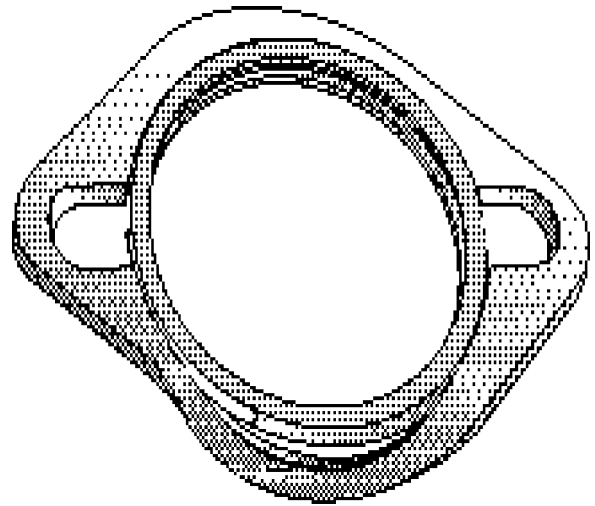
The gaskets (P/N 627429) were measured and were .032 inch larger than the original gasket at the outside diameter. The new gaskets were marked "FAA/PMA" and were in unopened packages. The gaskets fit properly when installed on the Number 1 and Number 4 cylinders; however, interference with adjacent cylinders was found when they were installed on the Number 2 and Number 4 cylinders. (Refer to the following illustration.)

If other operators experience this problem, please report these occurrences so that a resolution can be initiated.
